Effects of bank vegetation in waterways with special reference to bank erosion, shear strength, root density and channel hydraulics

**Effects of Bank Vegetation in Waterways with Special
Reference to Bank Erosion, Shear Strength, Root Density and
Channel Hydraulics**

**A thesis submitted to the Open University
for the Degree of Doctor of Philosophy
Biology Department
September 1992**

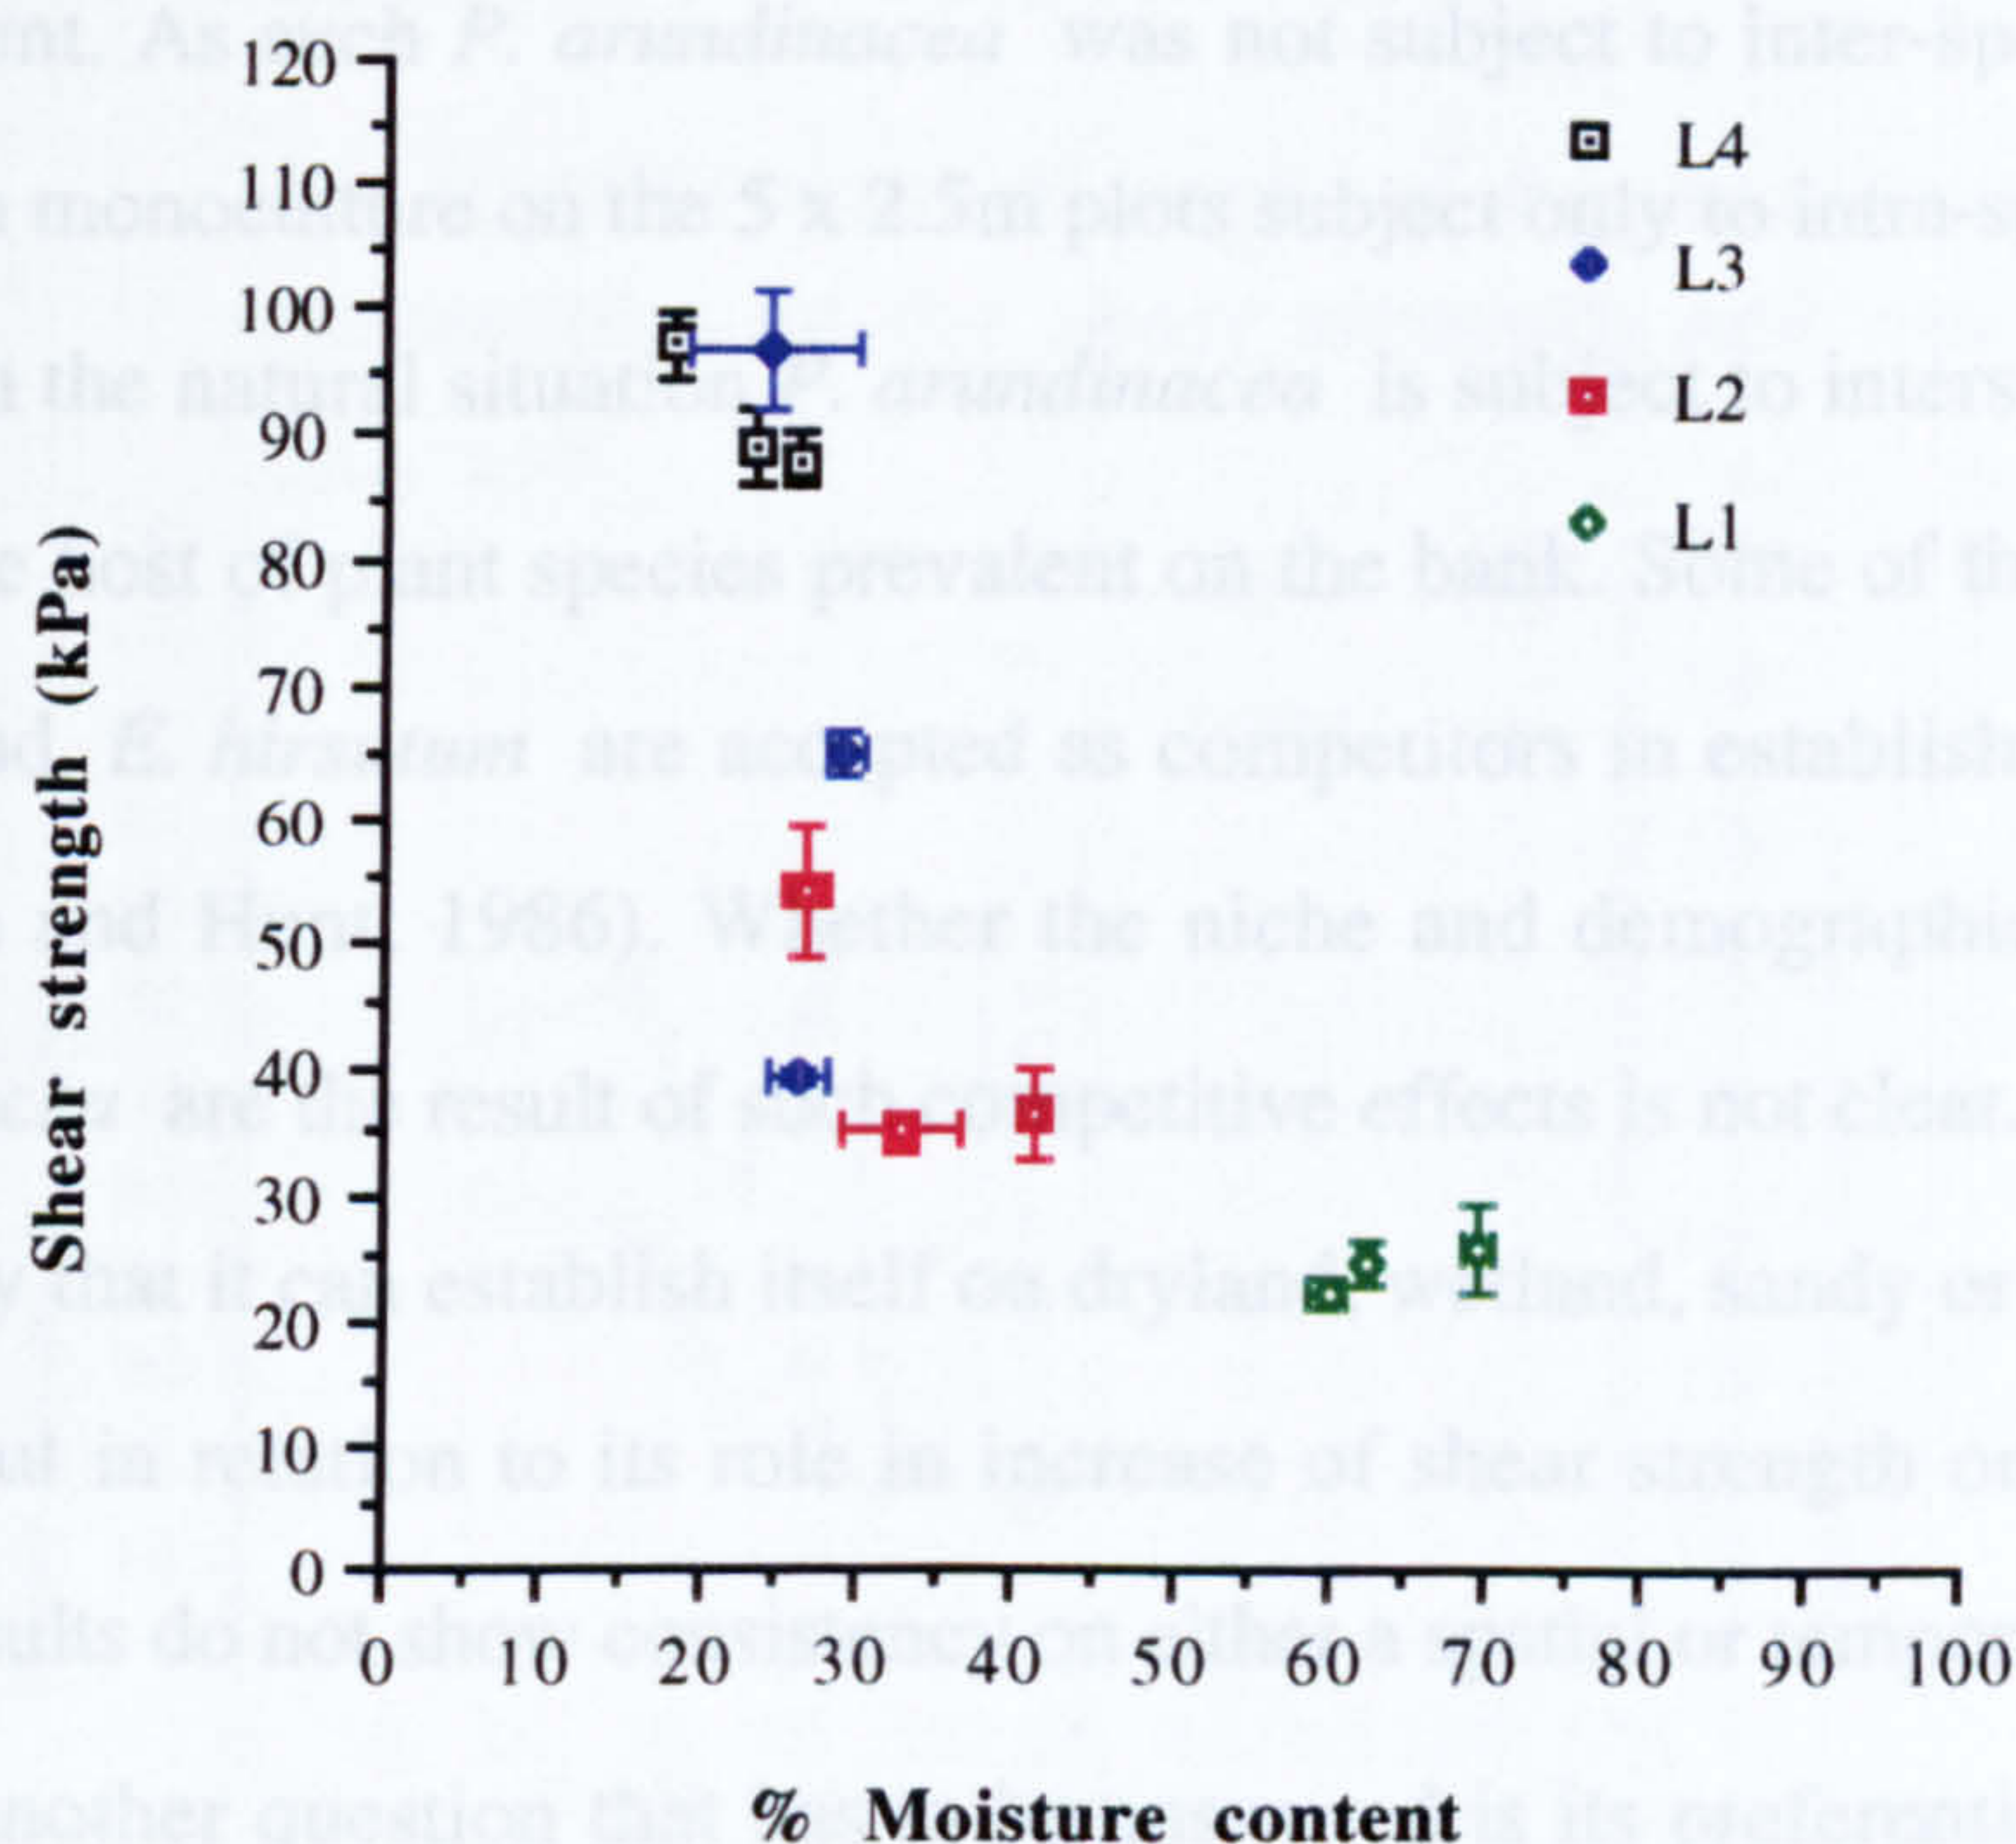
Fig. 4.13: Shear strength Vs. Moisture content variations (August 1988)
P. arundinacea cultivated banks

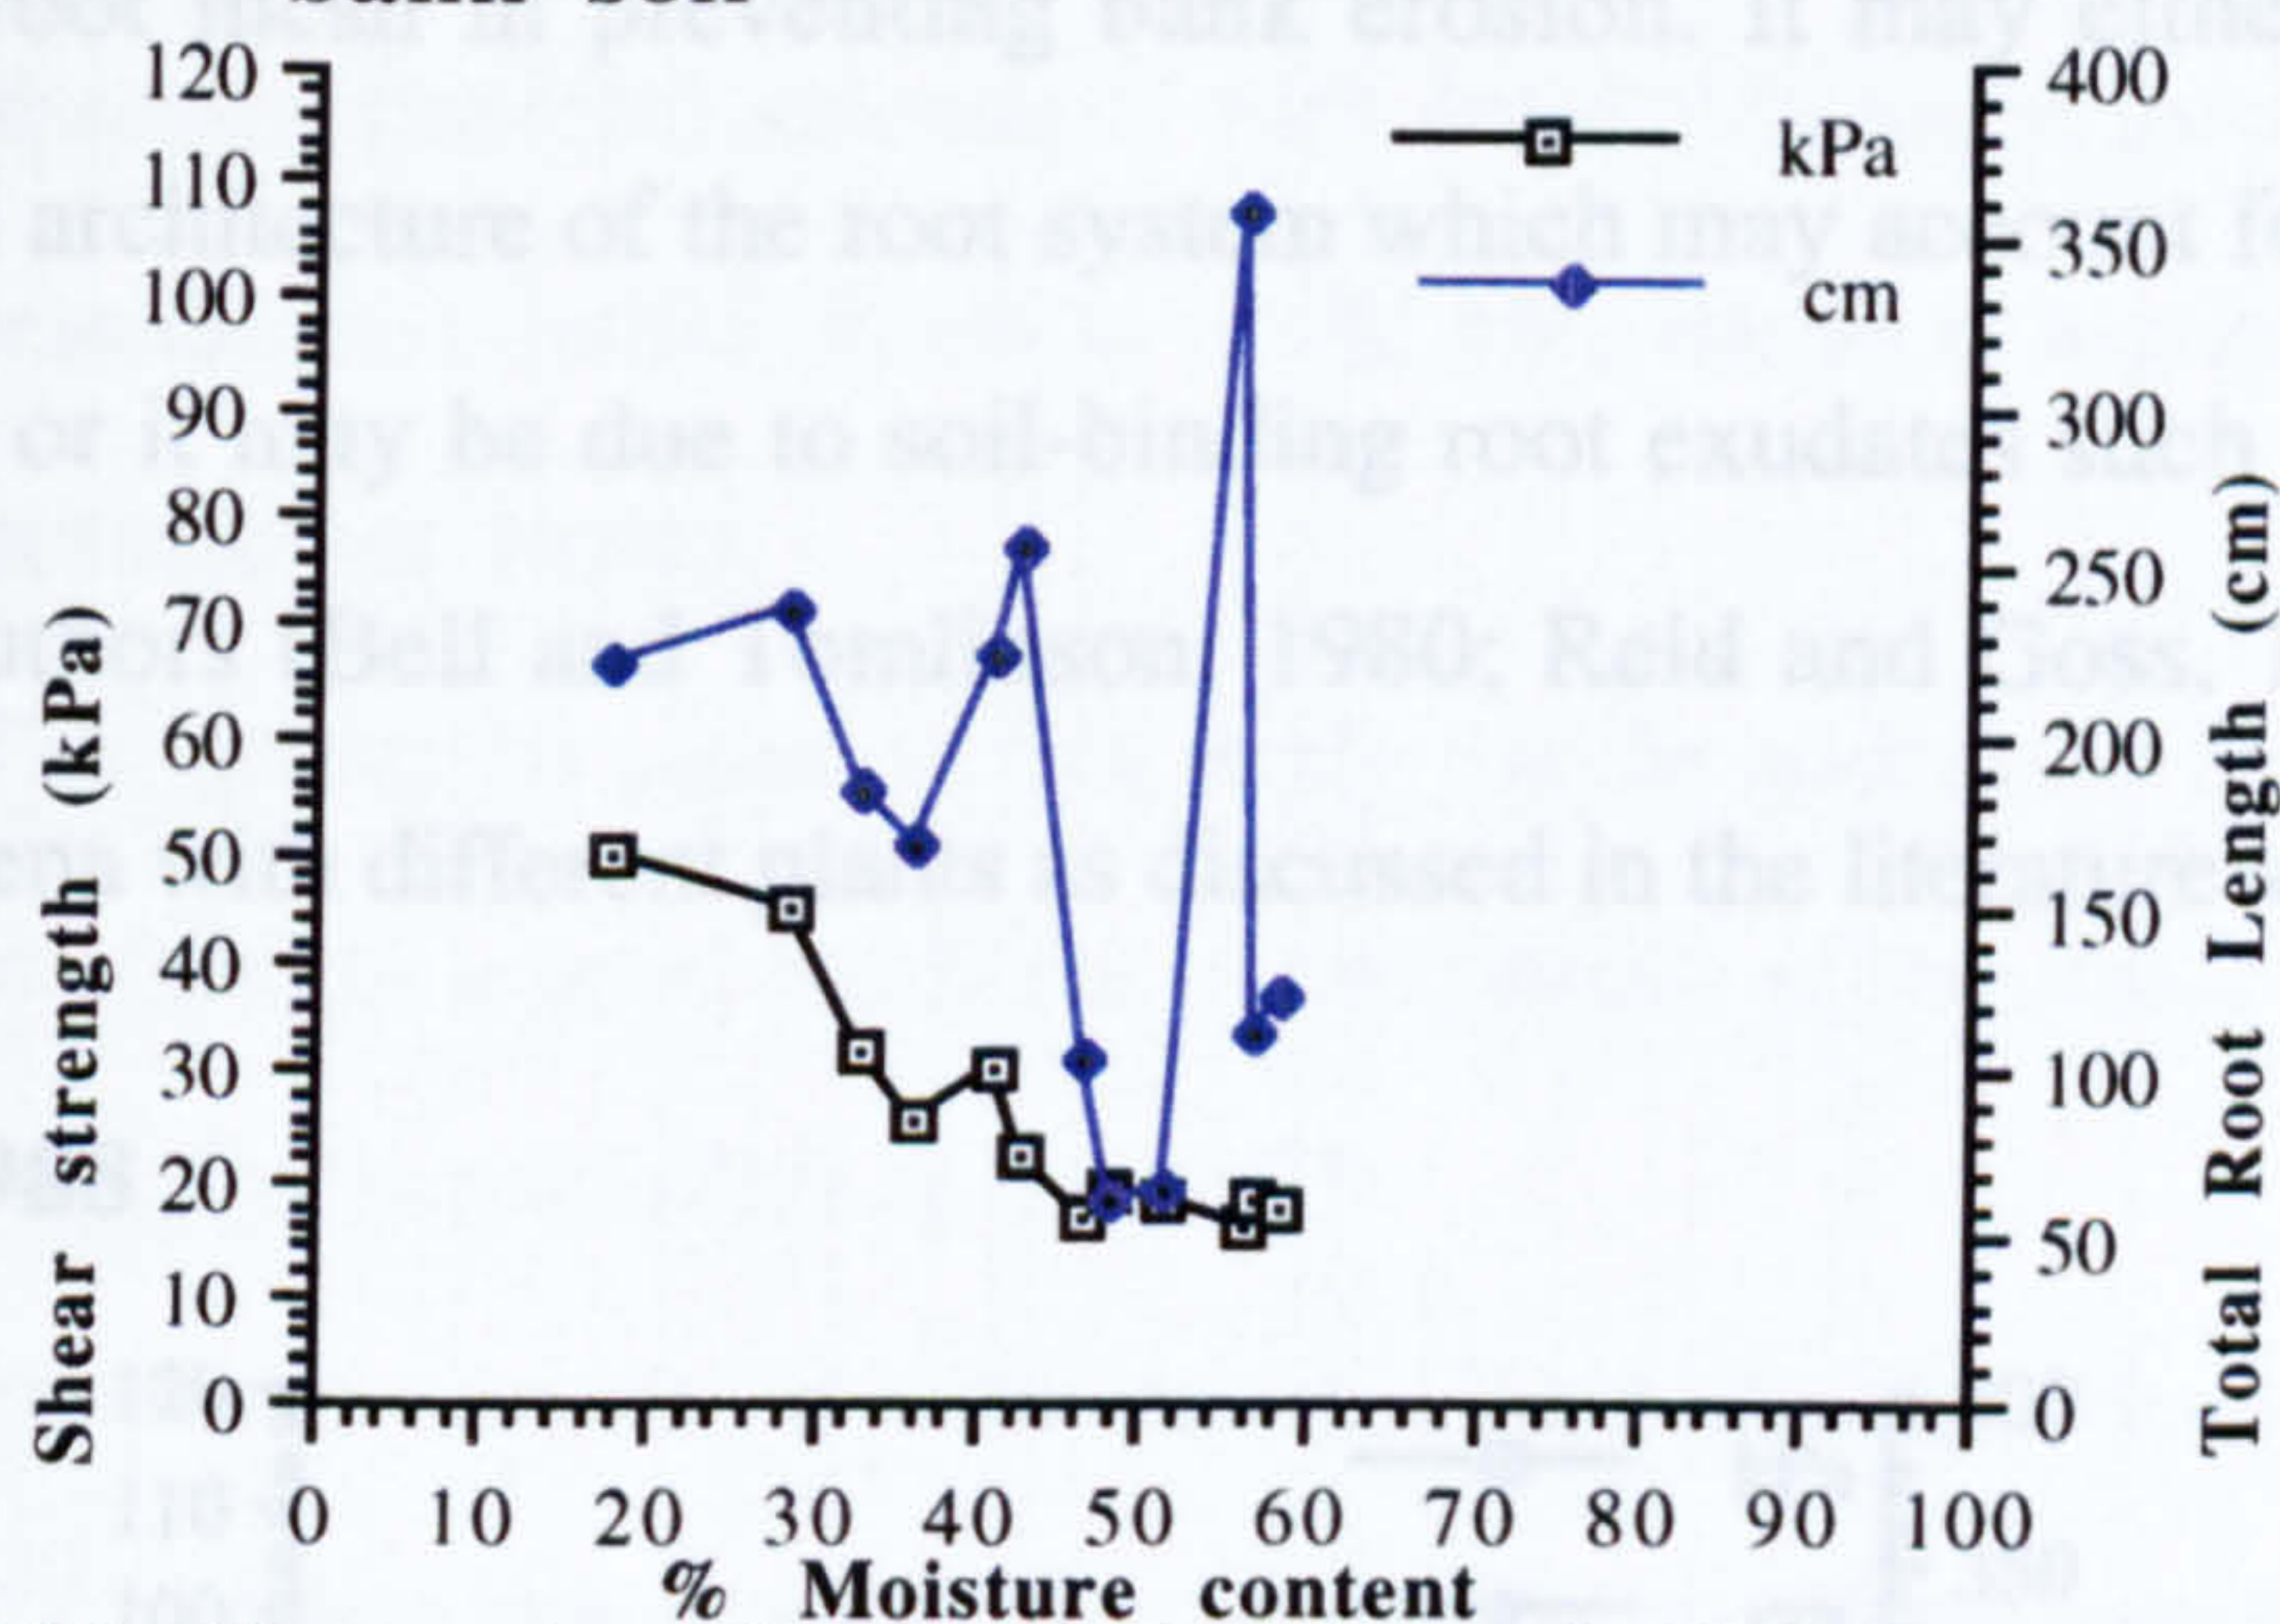
Fig.4.14: Shear strength, Root length and Moisture content variation (February 1988) *P. arundinacea* cultivated banks

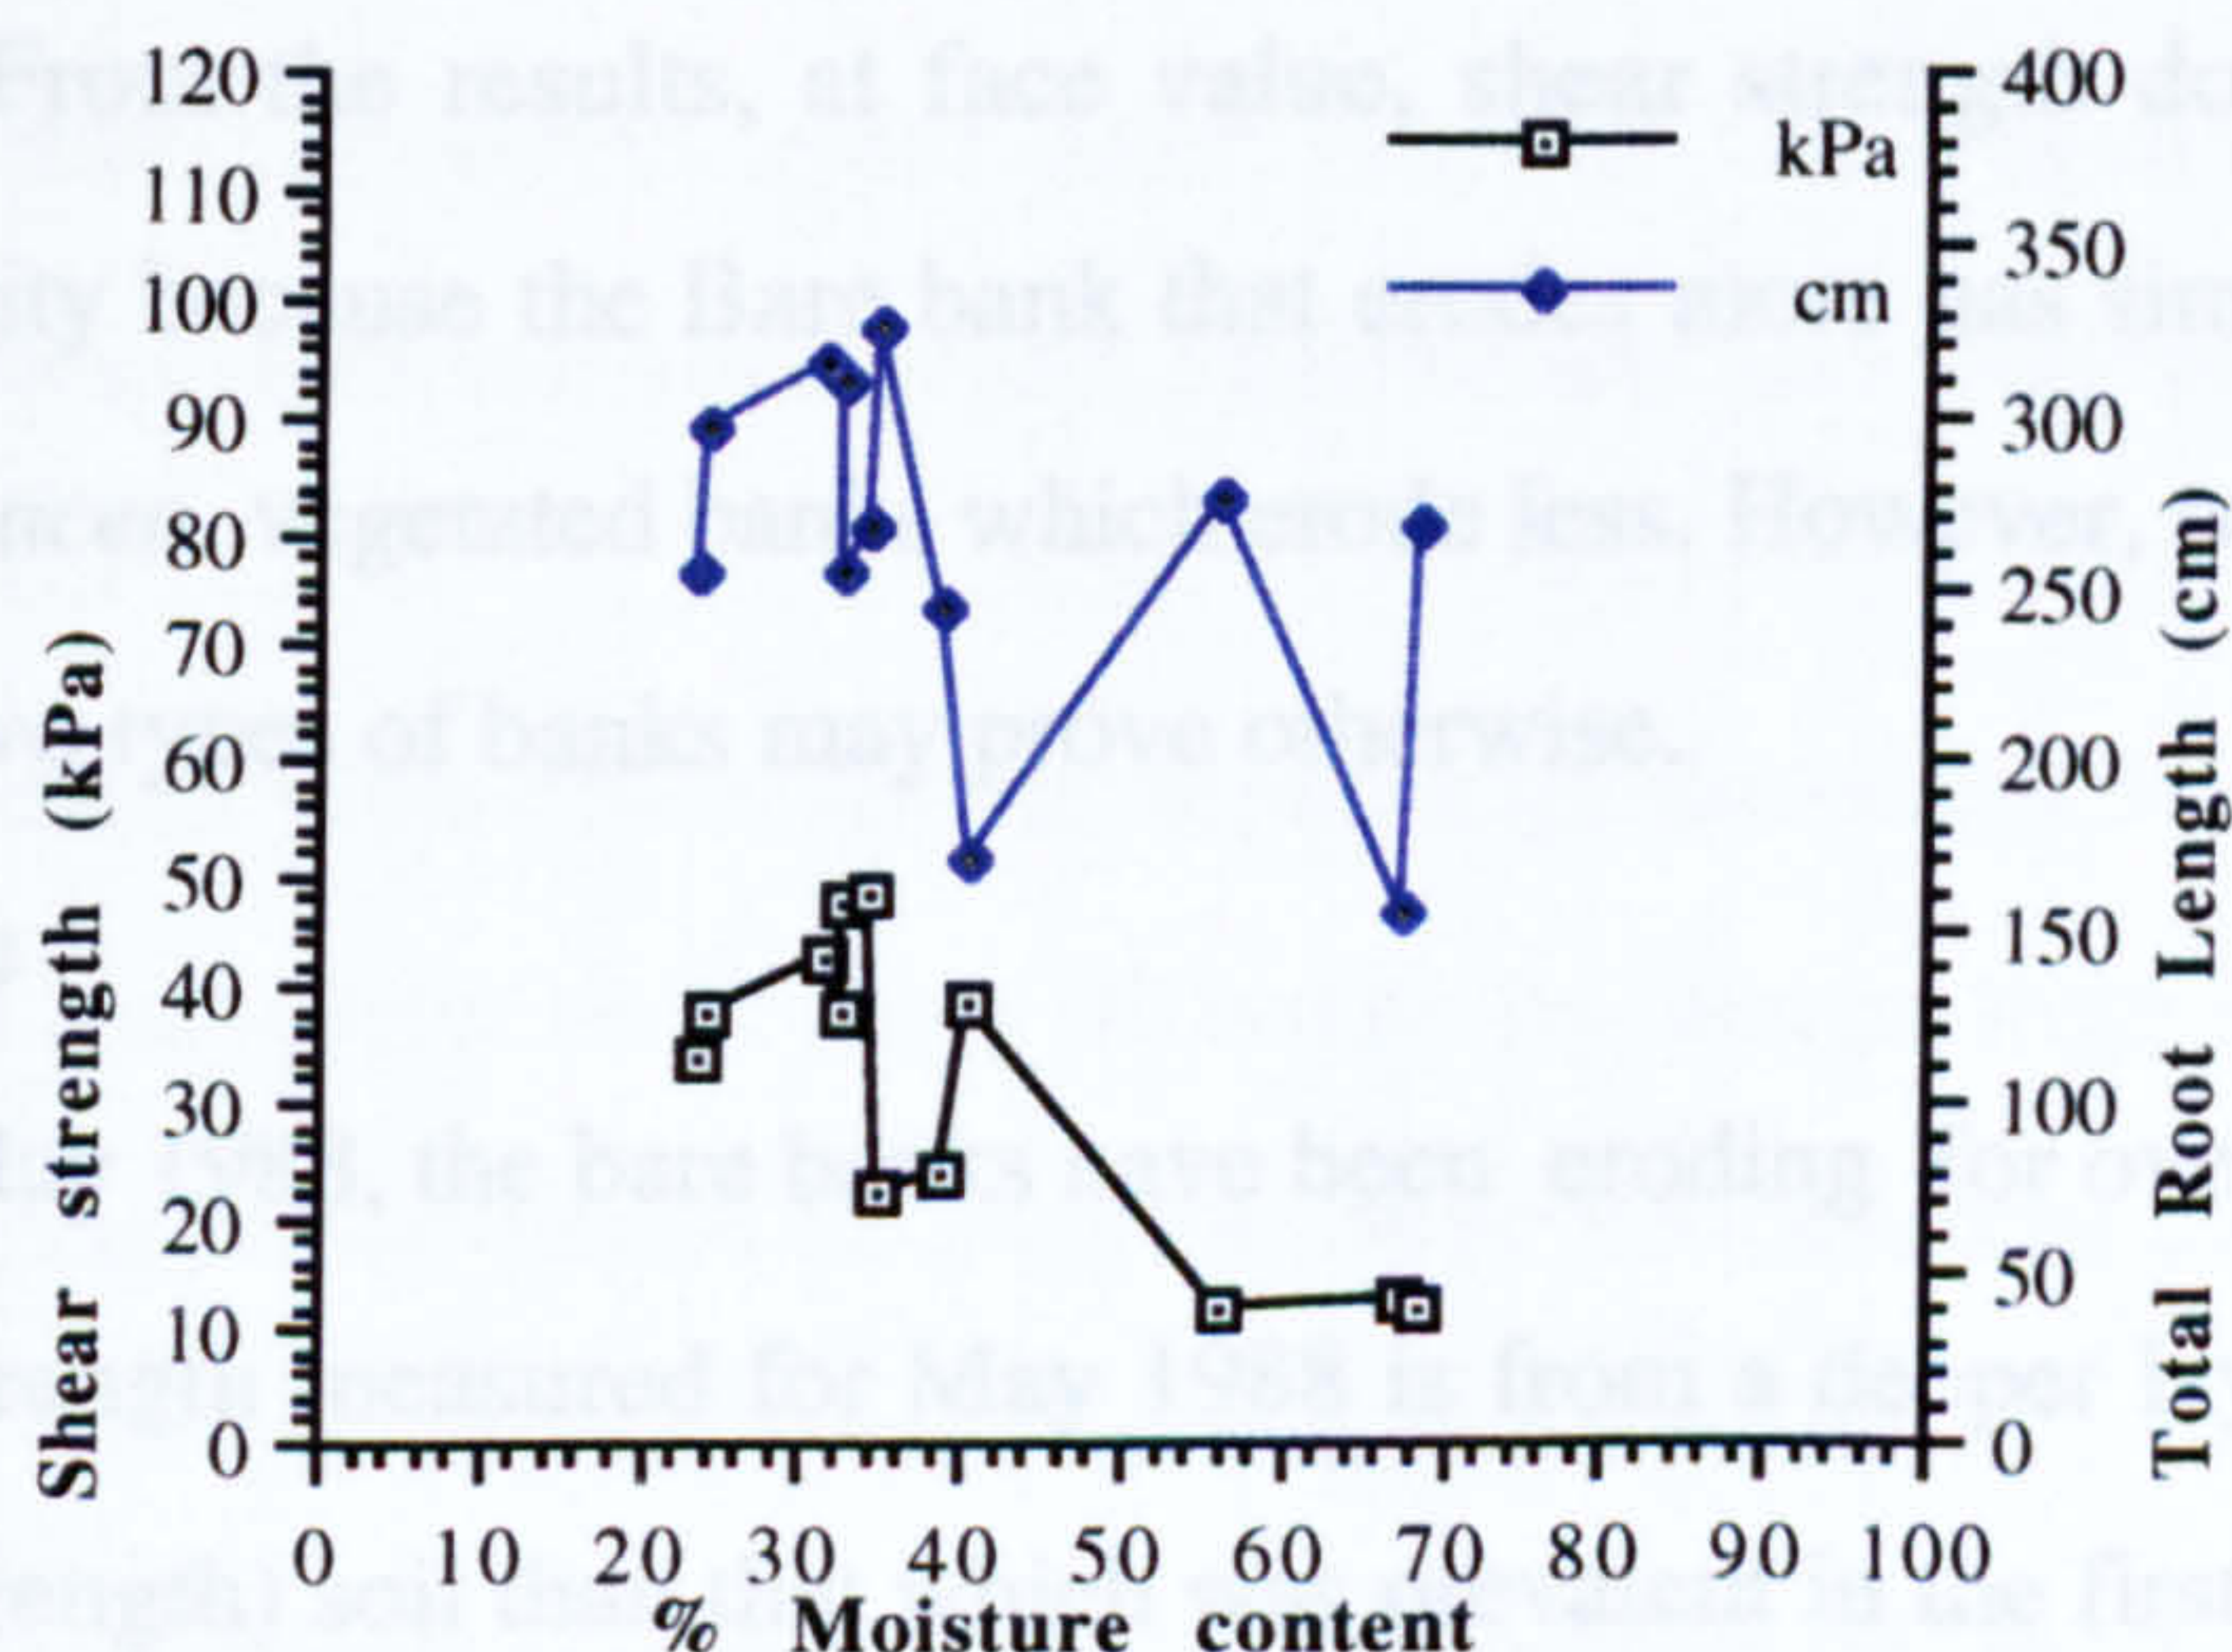
Fig. 4.15: Shear strength, Root length and Moisture content variation (May 1988)
P. arundinacea cultivated banks

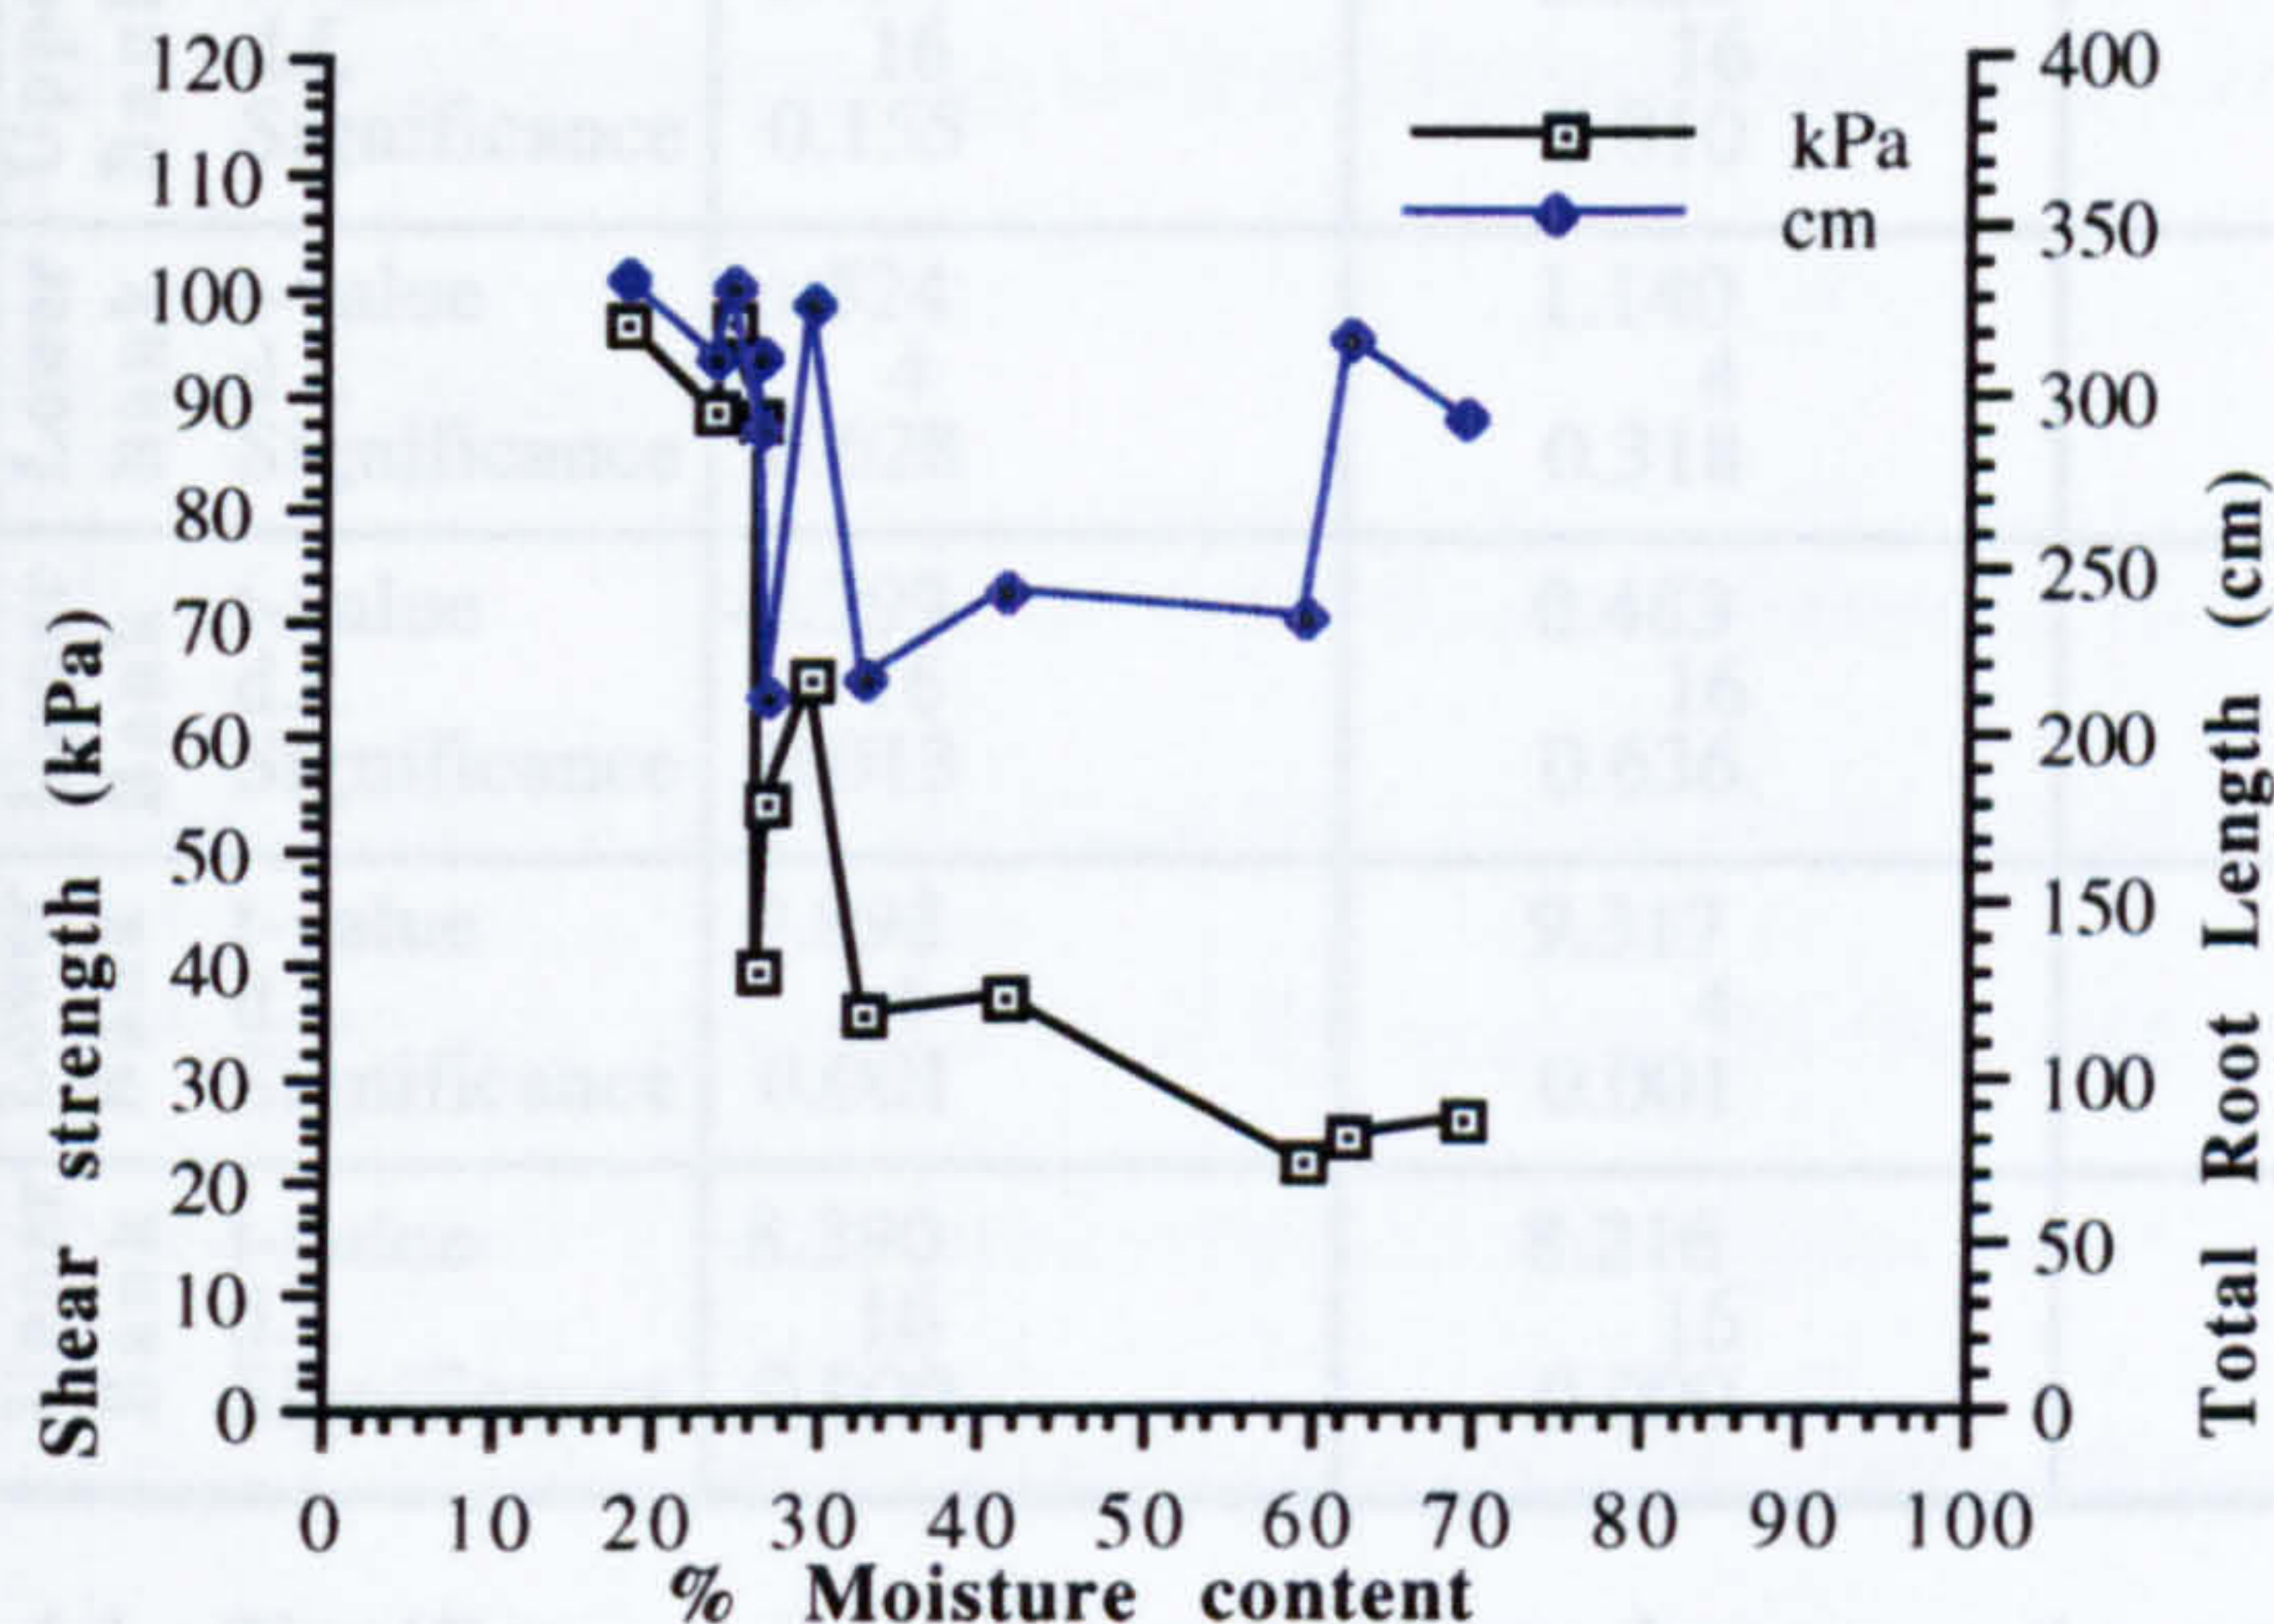
Fig. 4.16: Shear strength, Root length and Moisture content variations (August 1988) *P. arundinacea* cultivated banks

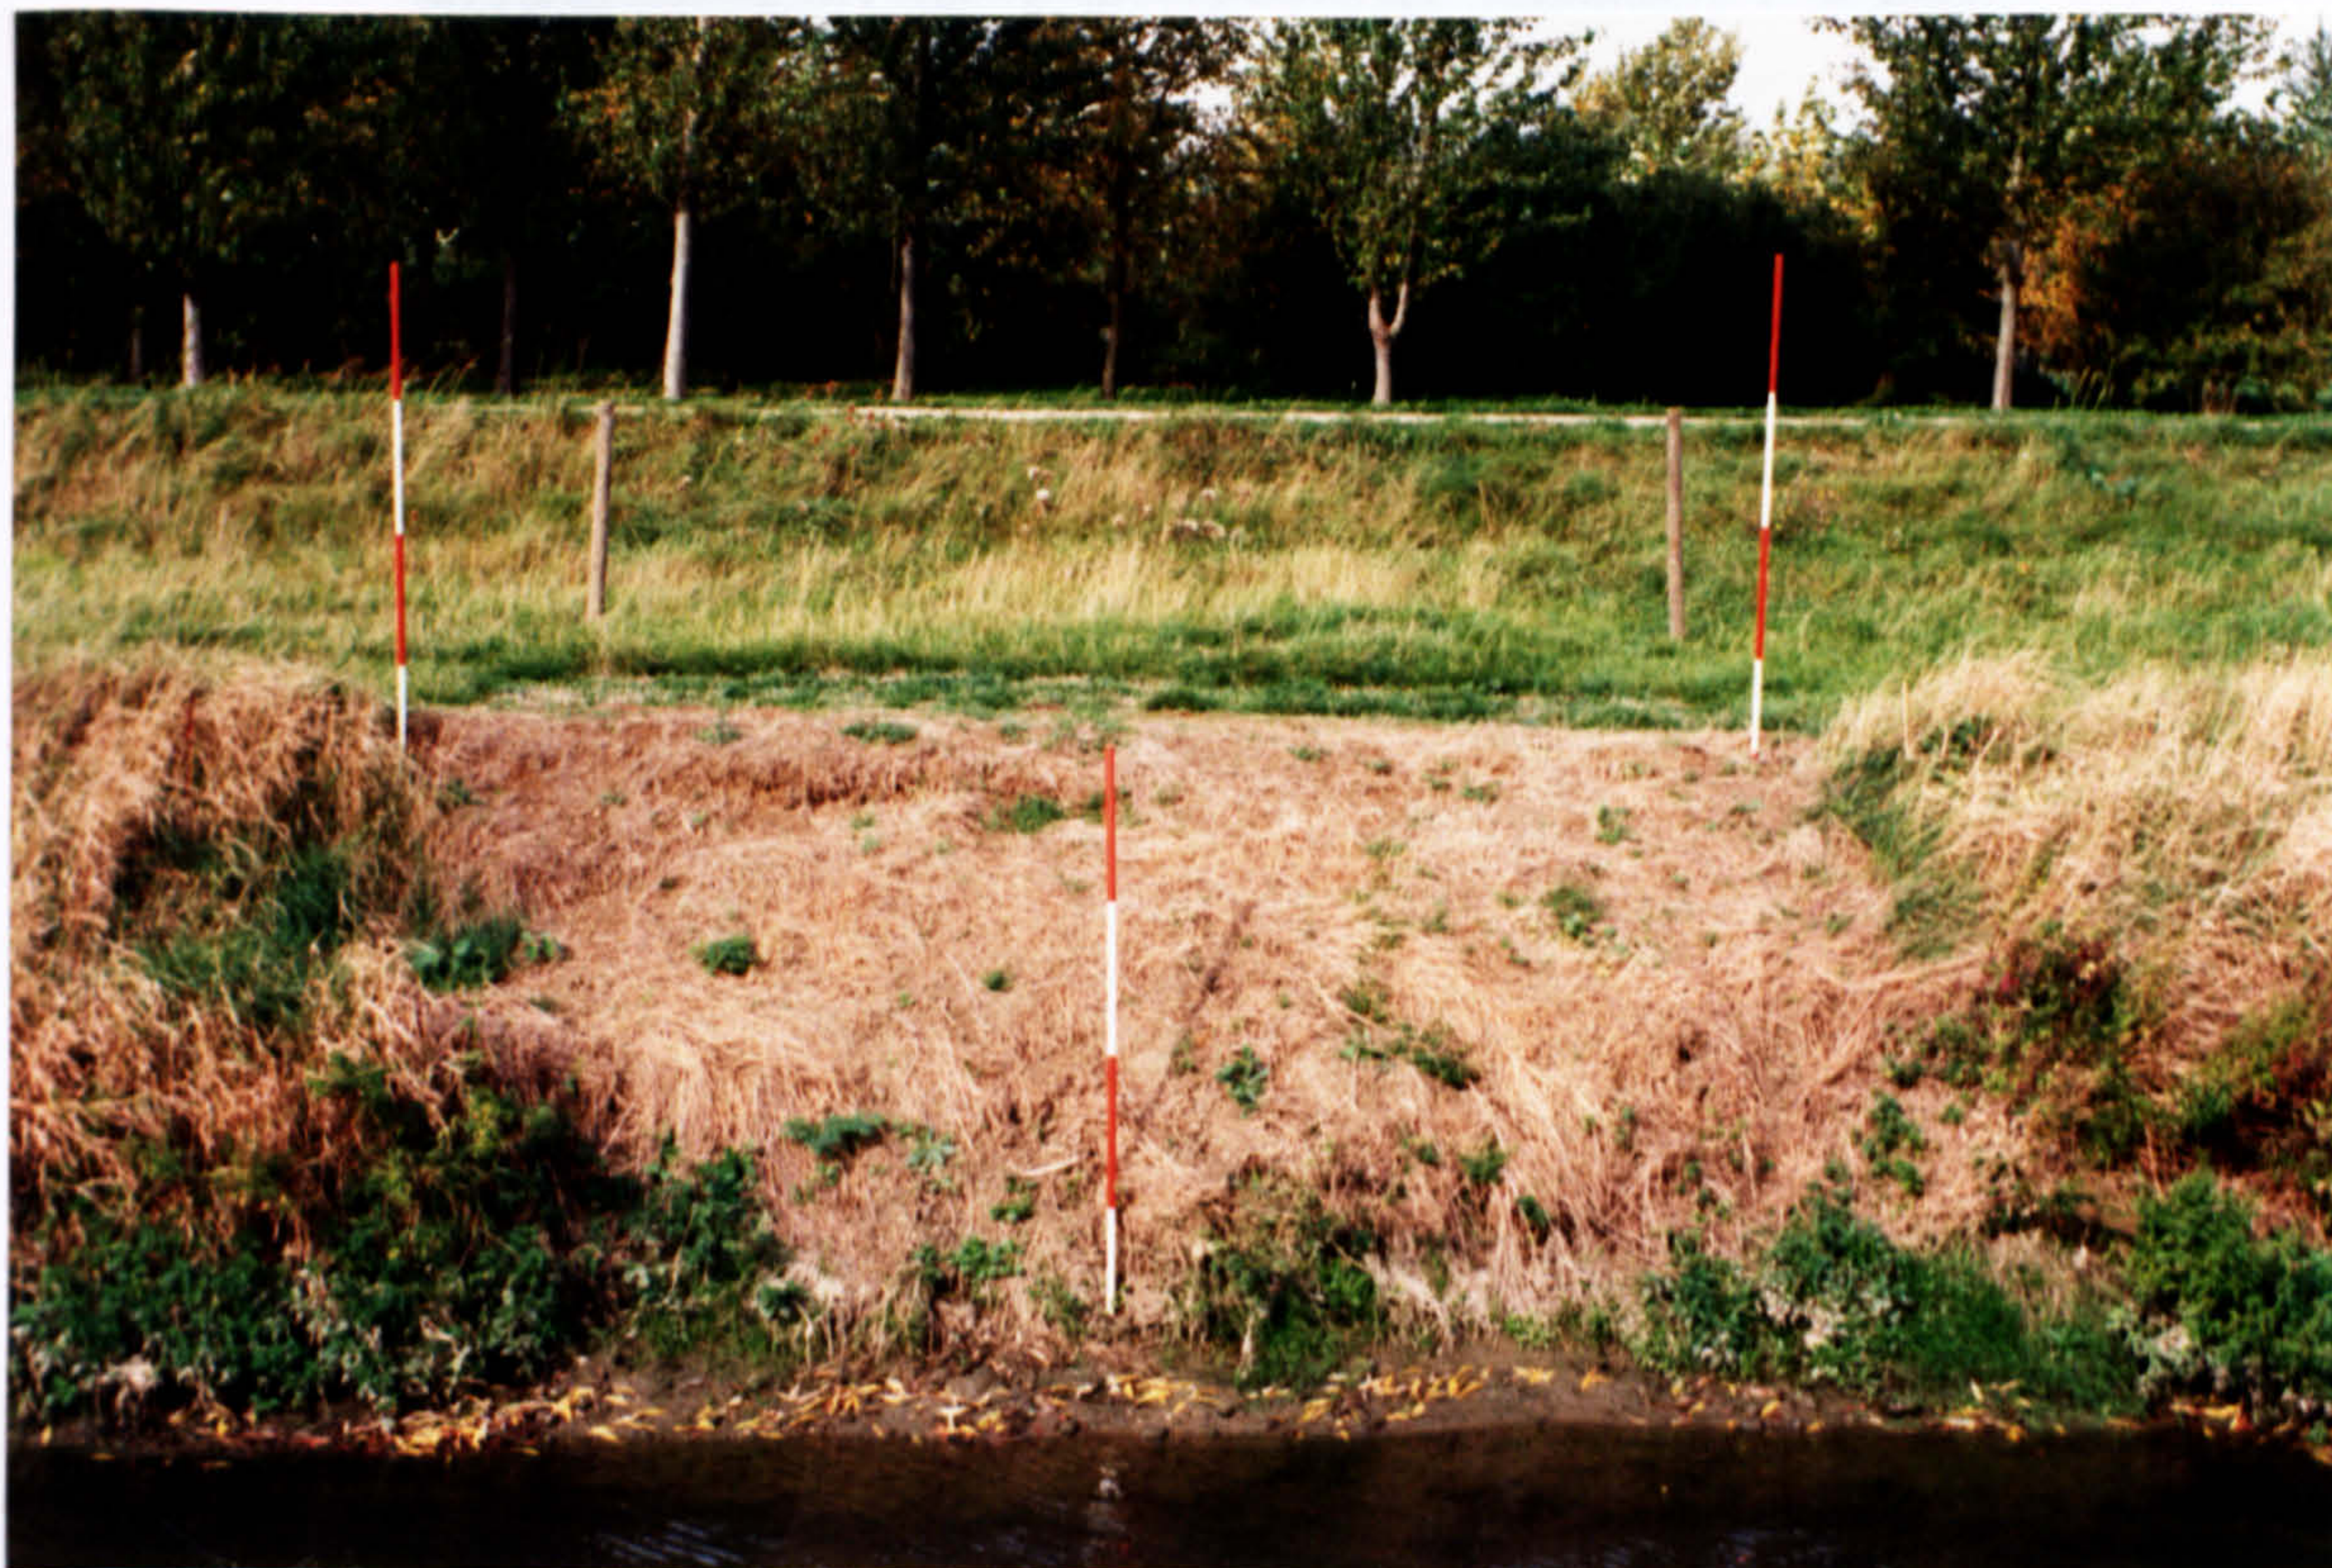
Plate 9. **De-vegetated bank assigned for natural re-vegetation (September 1986)**
 N.B. thick layer of dead vegetation left intact

are well known as deep-rooting colonisers. In addition one is referred to Plates 9, 10 and 11 as evidence of the fast re-colonisation of a devegetated plot from first summer (Plate 9, approximately four months after application of herbicide) to the third summer (Plate 10, early 2nd summer to Plate 11, late 2nd summer). (N.B. the word 'consolidation' of the bank soil is considered more appropriate to this study as it is controversial to allocate the effects of increased root density to increase in shear strength of the bank. Therefore it has to be concluded that natural re-vegetation is efficient to prevent slumping of banks under storm flows or flooding.

a) Phase 1 The effect of dead vegetation cover on the banks is reflected in the lower rates of erosion for the lower banks allocated for natural re-vegetation. Note the newly emergent vegetation at the bank toe-region in Plate 9. Compare this with the complete absence of such fringe vegetation in the long established natural vegetation in Plate 5.

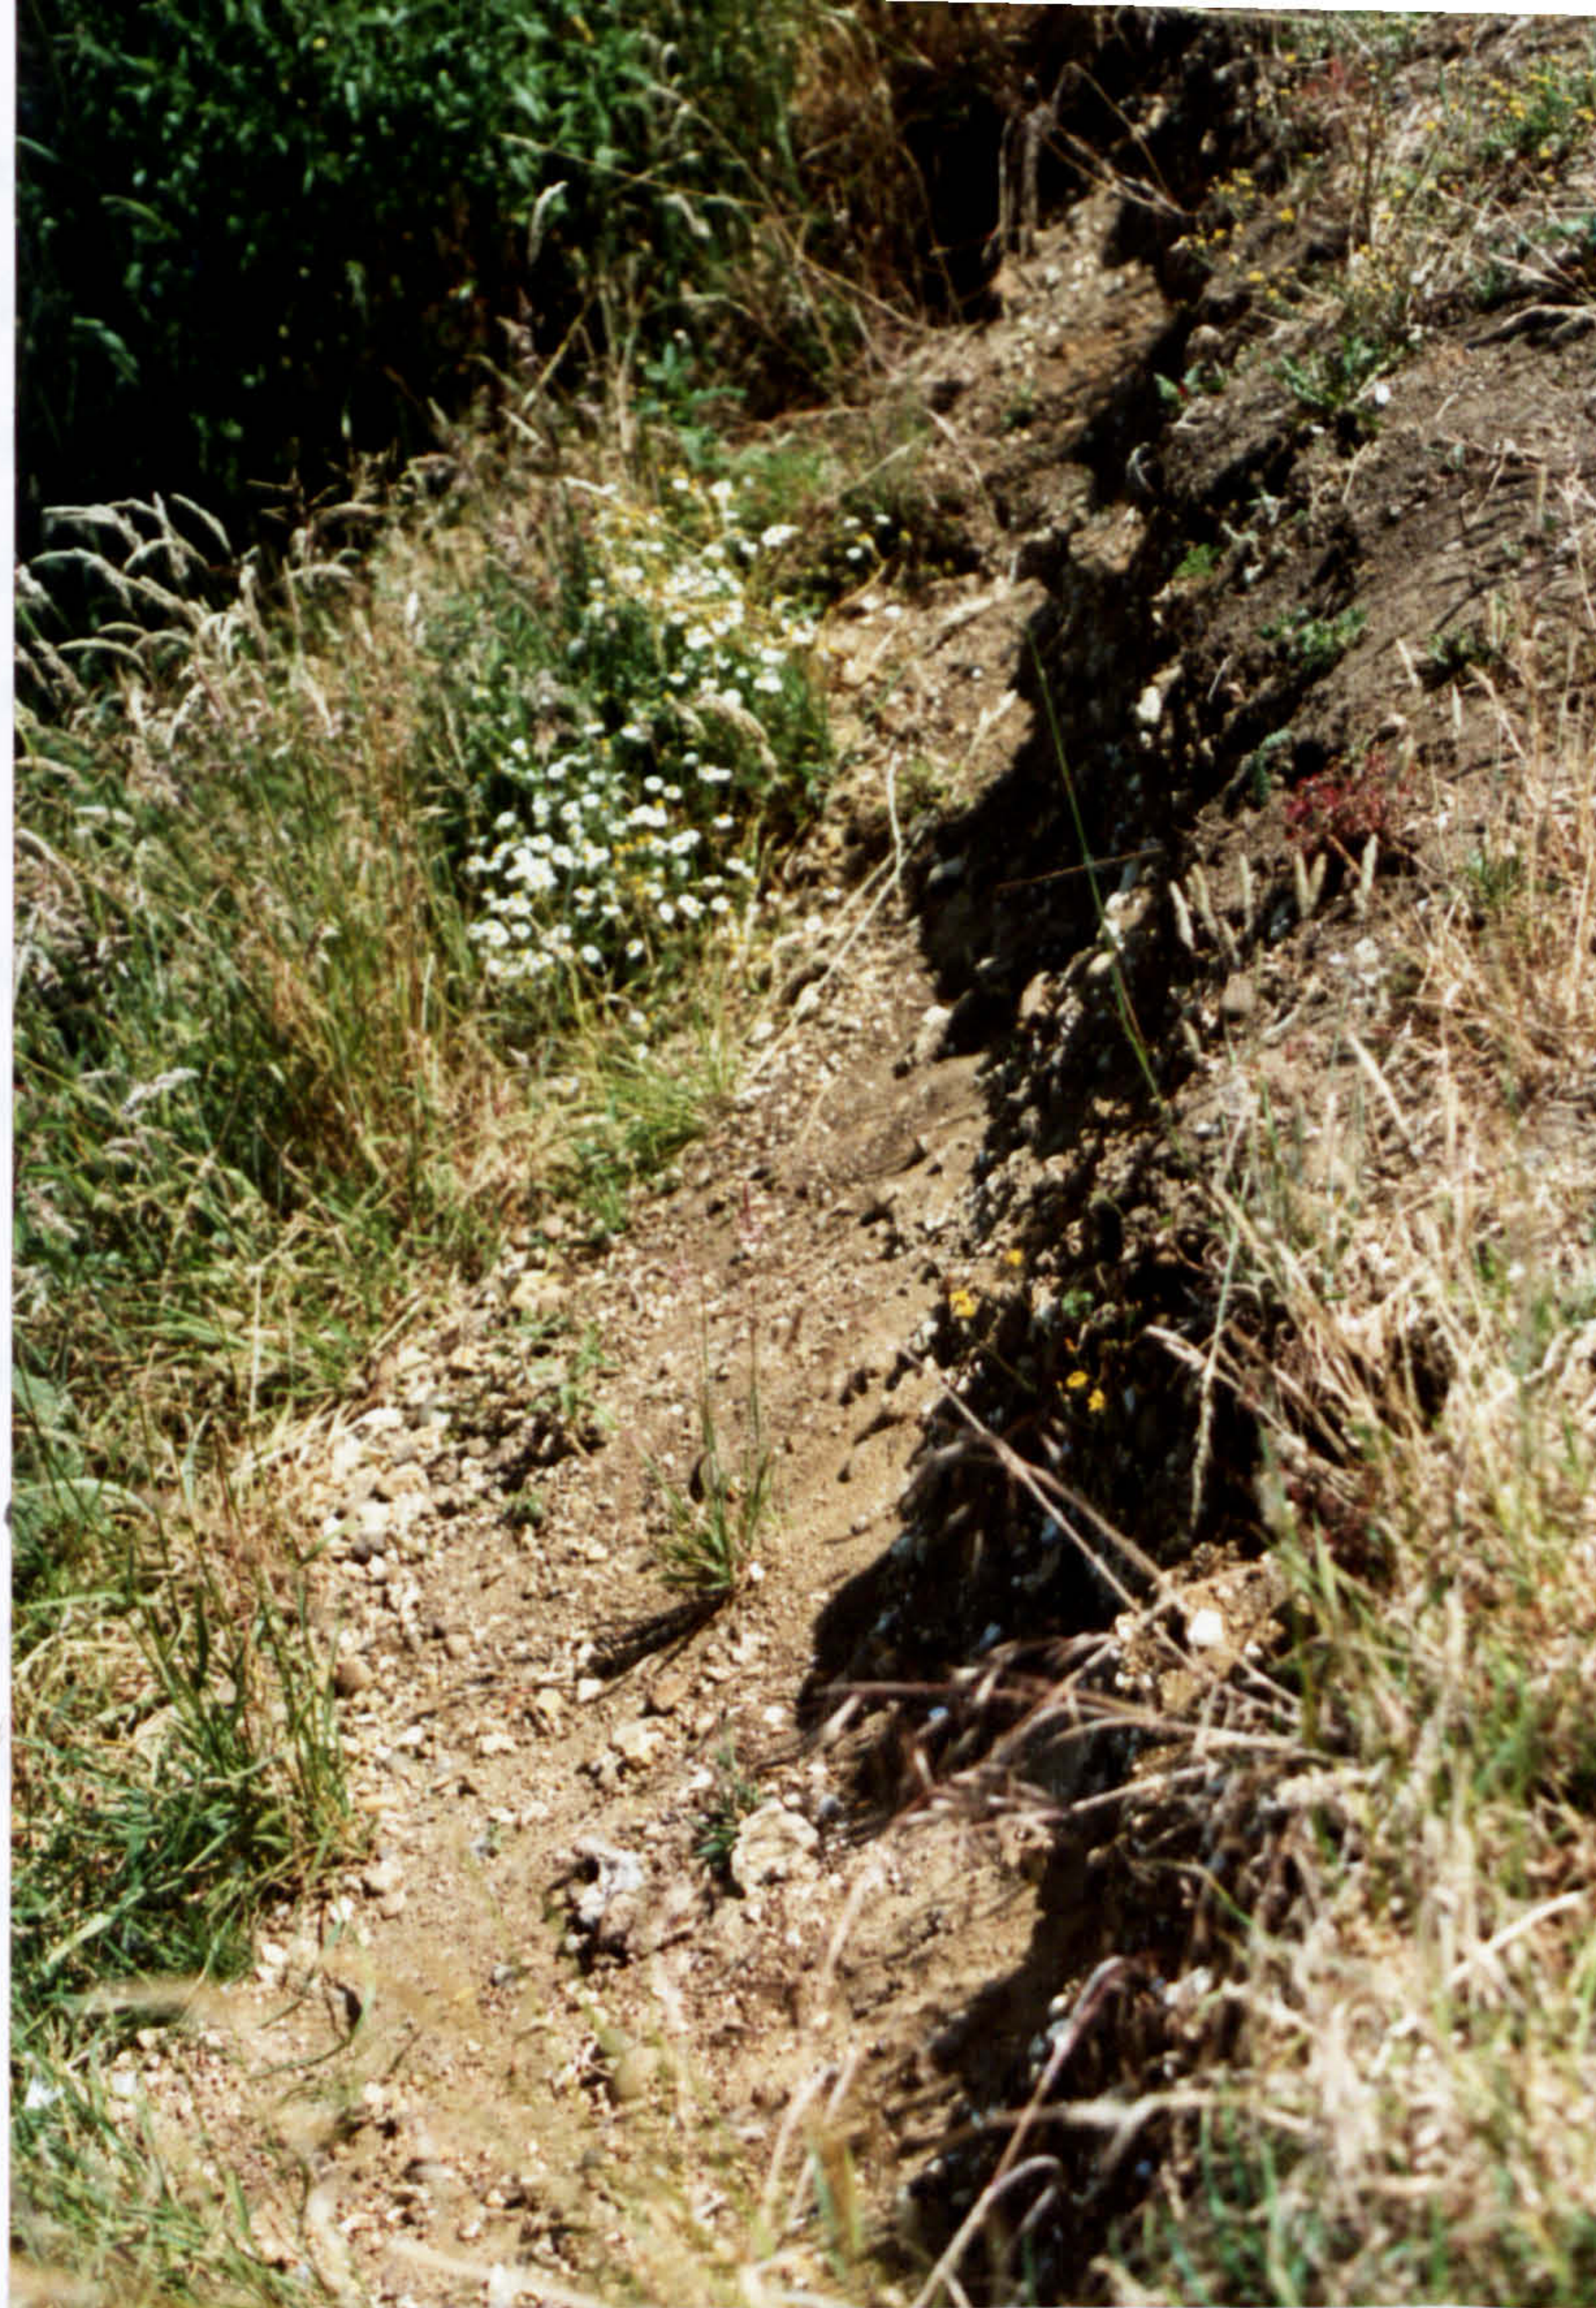
Plate 11. Upper bank (levels 3 to 4) of a naturally re-vegetated bank with poor colonisation
 N.B. photographed along the bank (laterally); strip of dry, hollow bank almost devoid of vegetation

This region is dominated by different species of grasses from April 1987 throughout to May 1988. However the mid- region was not well colonised even by July 1988 due probably to the more unstable soil compounded by a high gradient and the dry soil (see Plate 11).
